No. N° AV-2003-06	1/2
Date 2003-11-10

SERVICE DIFFICULTY ADVISORY

ISRAEL INDUSTRIES ASTRA SPX NOSEWHEEL STEERING BRACKET FAILURE

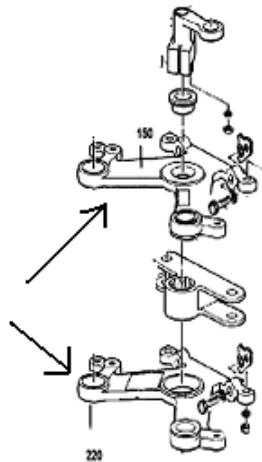
Initial findings indicate the nosewheel steering upper (P/N 2249.0110.001) and lower (P/N 2249.0120.001) attachment brackets, were broken. Testing of the brackets has shown the upper bracket had previously failed, and the lower failure happened at the time of this accident. Due to the location of the upper bracket, inspection is difficult without the aircraft on jacks and the defect was not detected on the aircraft preflight. Both of these parts may have been previously damaged during towing.

Nosewheel steering towing limitations are often exceeded on many aircraft resulting in potential damage. Transport Canada reminds maintenance personnel and pilots of the paramount importance of briefing tow operators of these limitations. This should be done prior to the movement of the aircraft.
